FINAL REPORT OF FRACTURE SYSTEM INVESTIGATION
MODINE HEAT TRANSFER, INC.
CAMDENTON, MISSOURI

MISSOURI DEPARTMENT OF NATURAL RESOURCES
HAZARDOUS WASTE PROGRAM
JEFFERSON CITY, MISSOURI

Dames & Moore Job No. 27397-017-045
July 17, 1996

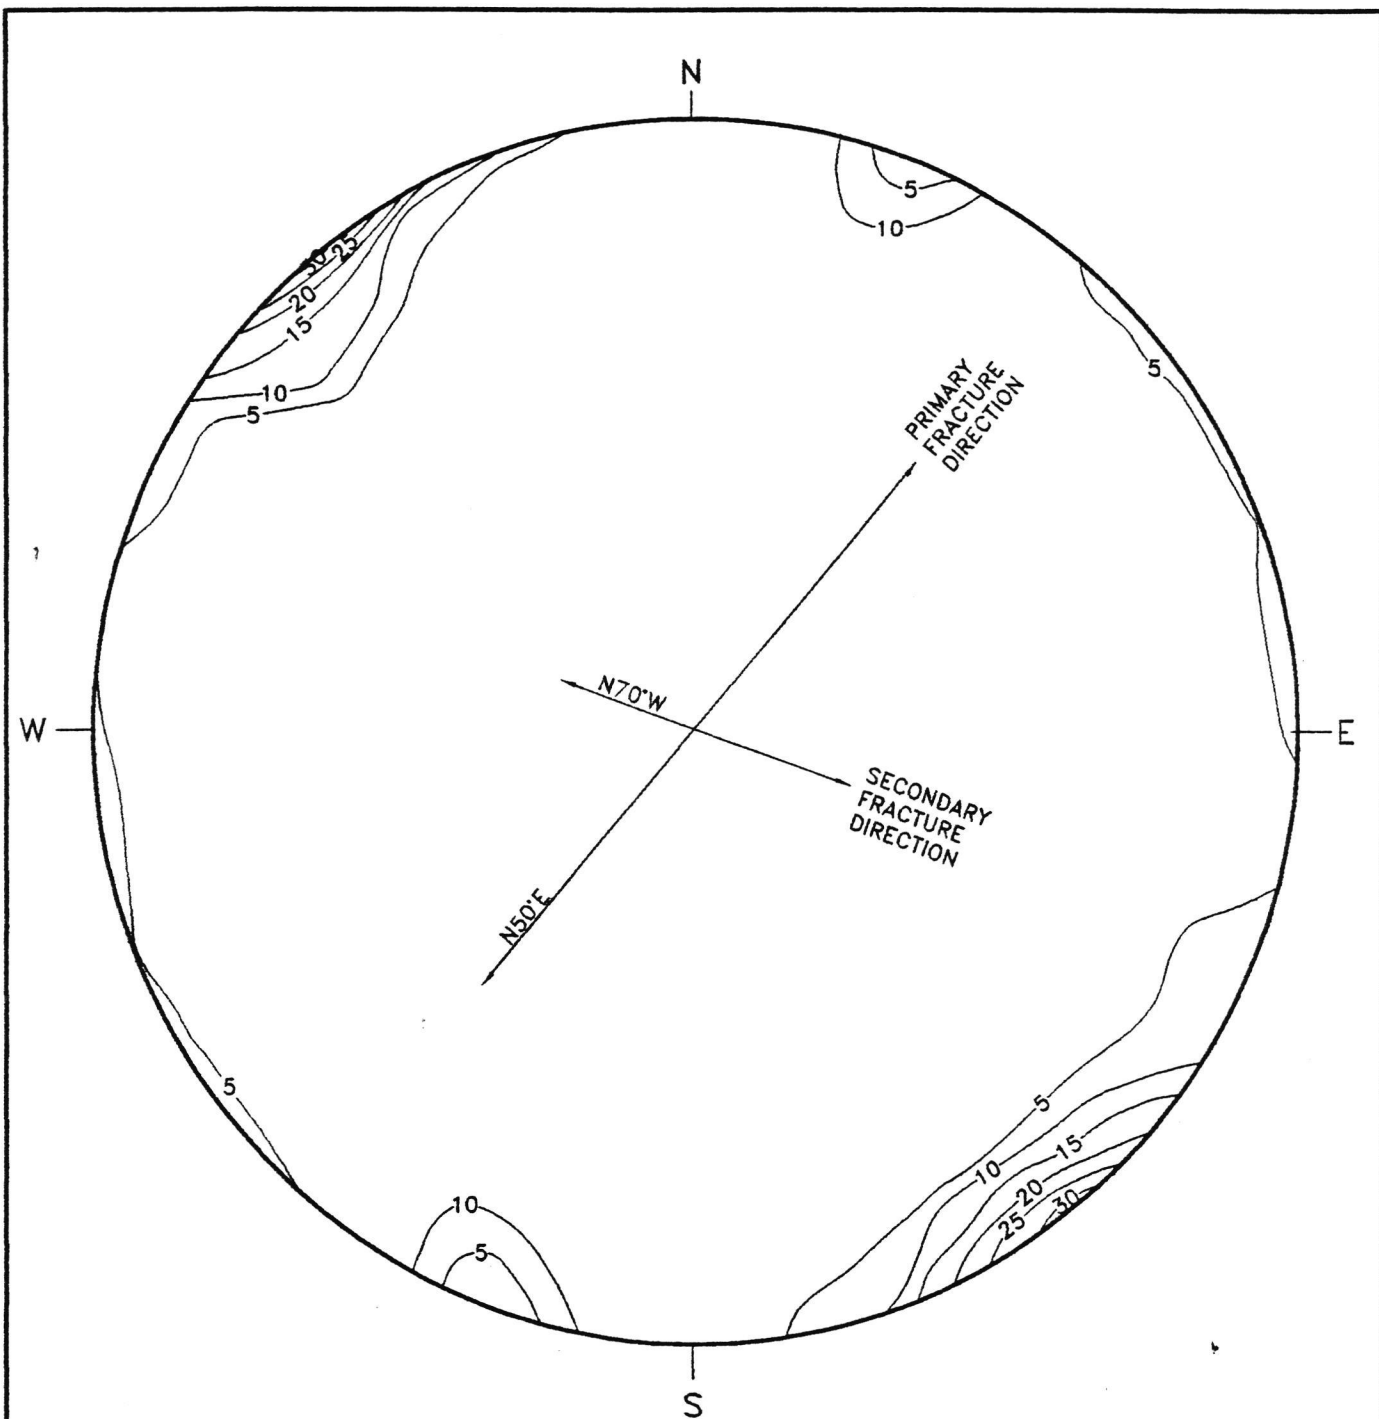
FIGURE 4
DIAGRAM OF
FRACTURE ORIENTATIONS

These fracture orientations were plotted on a contour diagram, using stereographic projection (Figure 4). This diagram is a contour diagram of the poles (perpendiculars) to the planes which were measured. The contours represent the frequency of the orientations in which the fracture poles (perpendiculars) occur. The following points are evident from this diagram.

- The vast majority of all of the fractures are vertical or nearly vertical. Inspection of the data in Appendix A demonstrates that only 5 of the 173 fractures were oriented at less than 75° from horizontal. Only one fracture was oriented less than 45° from horizontal.

- One strongly preferred orientation is apparent from the data set, represented by poles which plot in the northwest and southeast quadrants of the contour diagram. The orientations of the fractures which are represented by these poles are nearly vertical and trend overall N 50° E .
- A subordinate preferred orientation is represented by poles which plot in the northeast and southwest quadrants of the contour diagram. The orientations of the fractures which are represented by these poles are again nearly vertical and trend overall N 70° W.

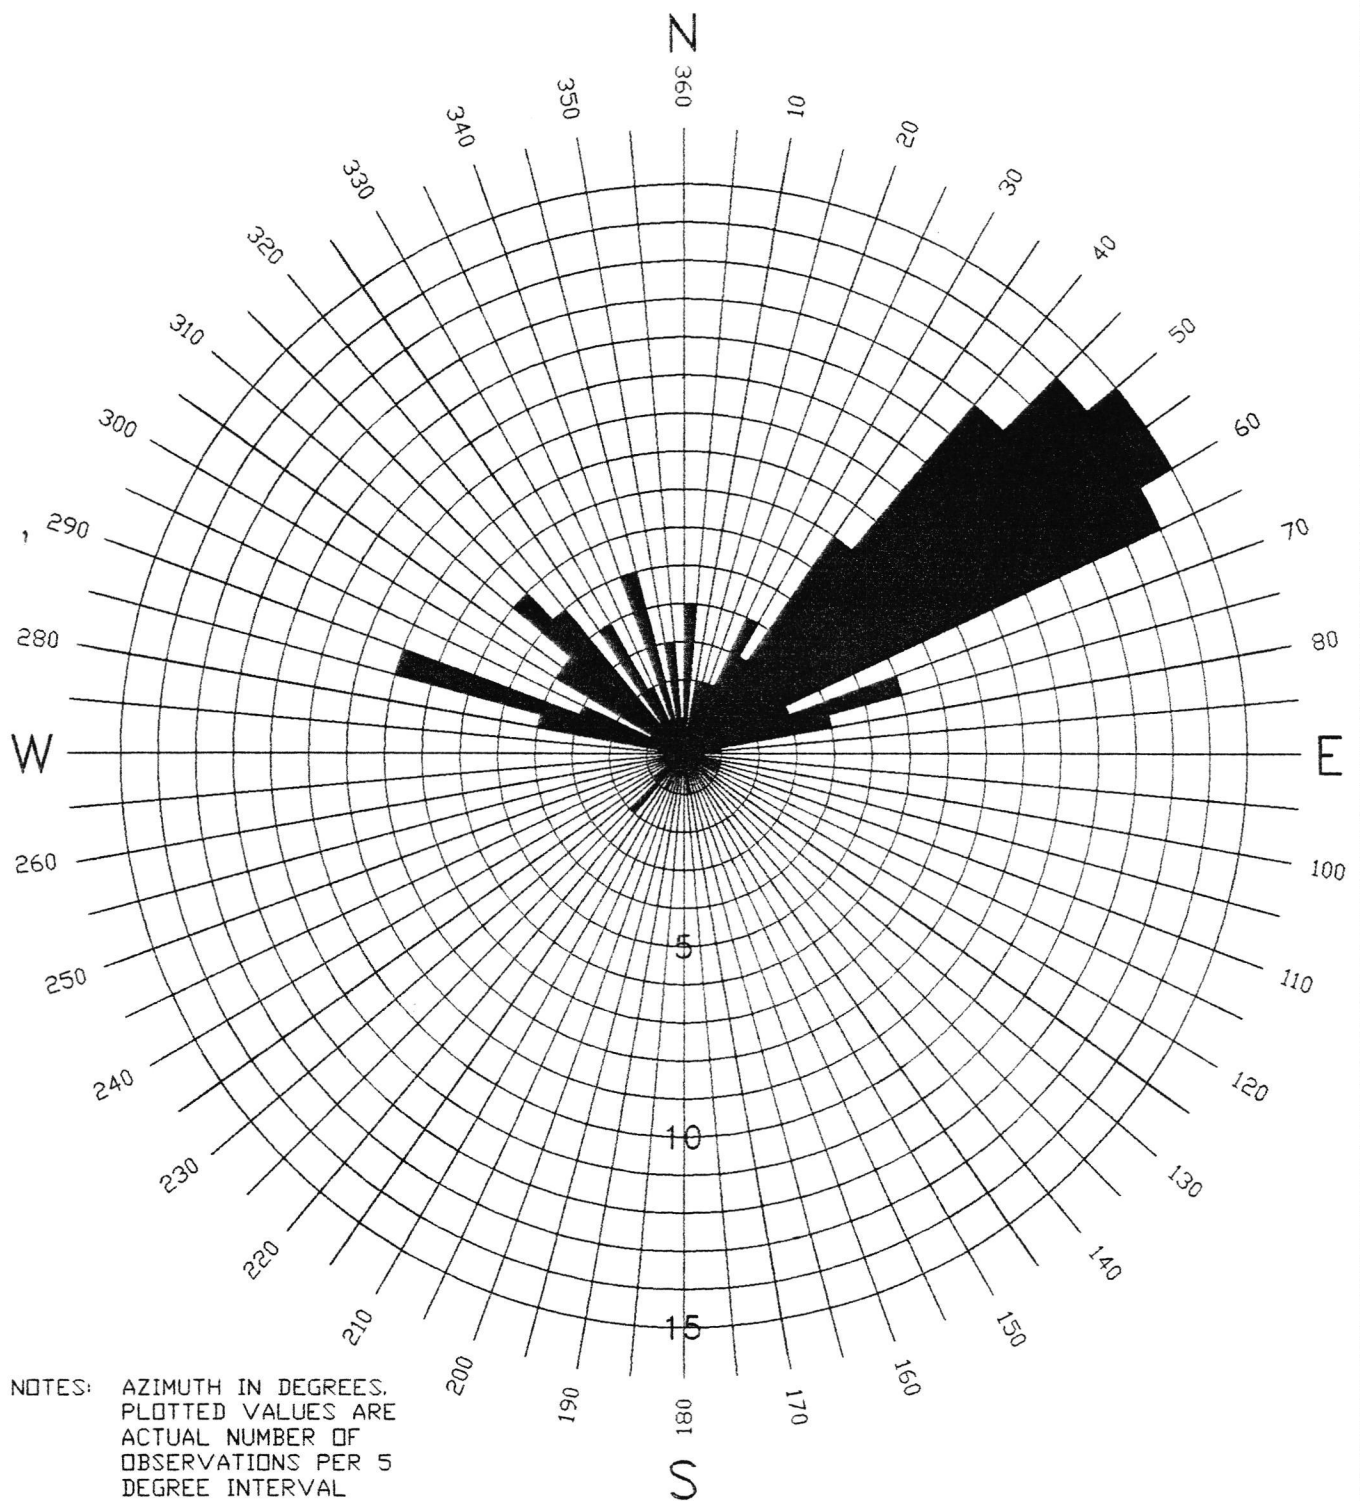
FIGURE 5
CIRCULAR HISTOGRAM
OF STRIKE AZIMUTHS

Preferred fracture orientations have been plotted on a circular histogram for greater clarity (Figure 5). Plotted values are azimuths of fractures and fracture dip is not represented in this diagram. The radial scale is the number of observations plotted within each five degree interval. This diagram demonstrates the overwhelming preponderance of fracture orientations which occur at approximately N 50° E. The diagram also shows the secondary fracture direction of approximately N 70° W. Figure 6 shows the preferred orientations for fractures as plotted at the location of MW-4. The primary preferred direction of fracturing is not consistent with an on-site source for impacted groundwater (see Section 6.0).

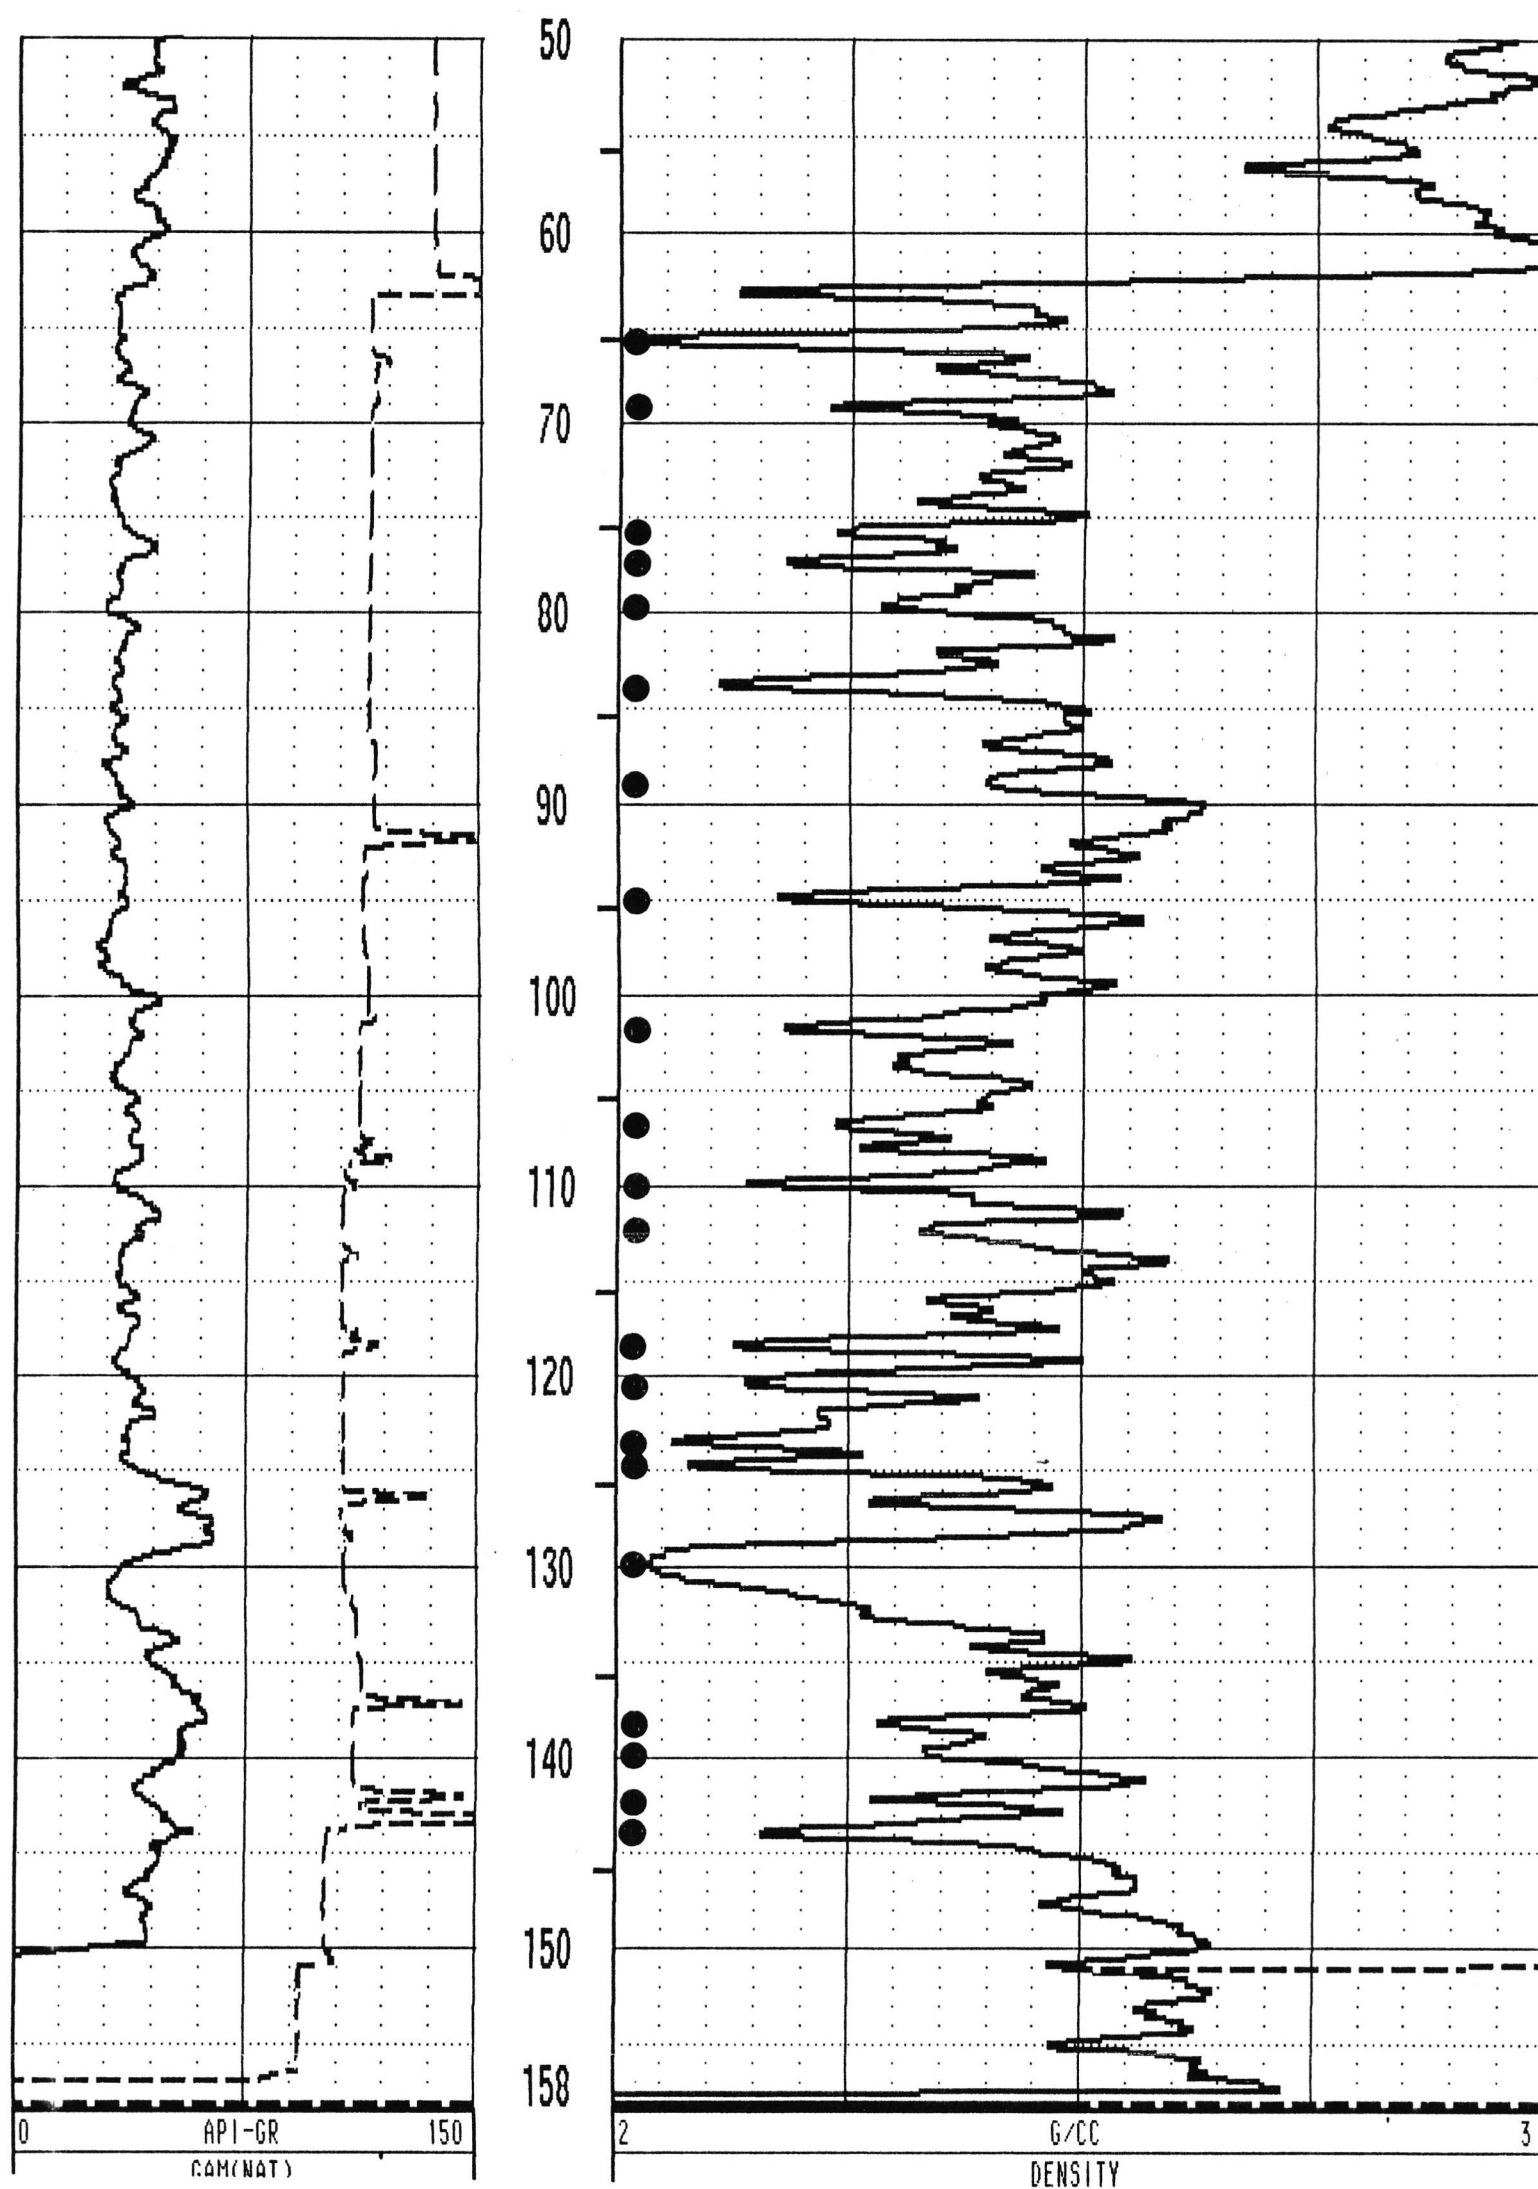
FIGURE 9
INTERPRETED FRACTURES
MW-3

The density log for MW-3 displays substantial spiking of low density events. In the apparent absence of rapid lithologic changes, these lower density spikes are interpreted as evidence of secondary porosity resulting from fractures. The gamma marker is represented as a local high in density, which suggests that the lithology of the marker lacks porosity. The gamma marker is indicated to be approximately four feet thick at a depth of 127.5 feet.

The neutron log for MW-3 generally supports the conclusions of the density log. A substantial number of spikes toward lower neutron response support the presence of fracturing in the rock.

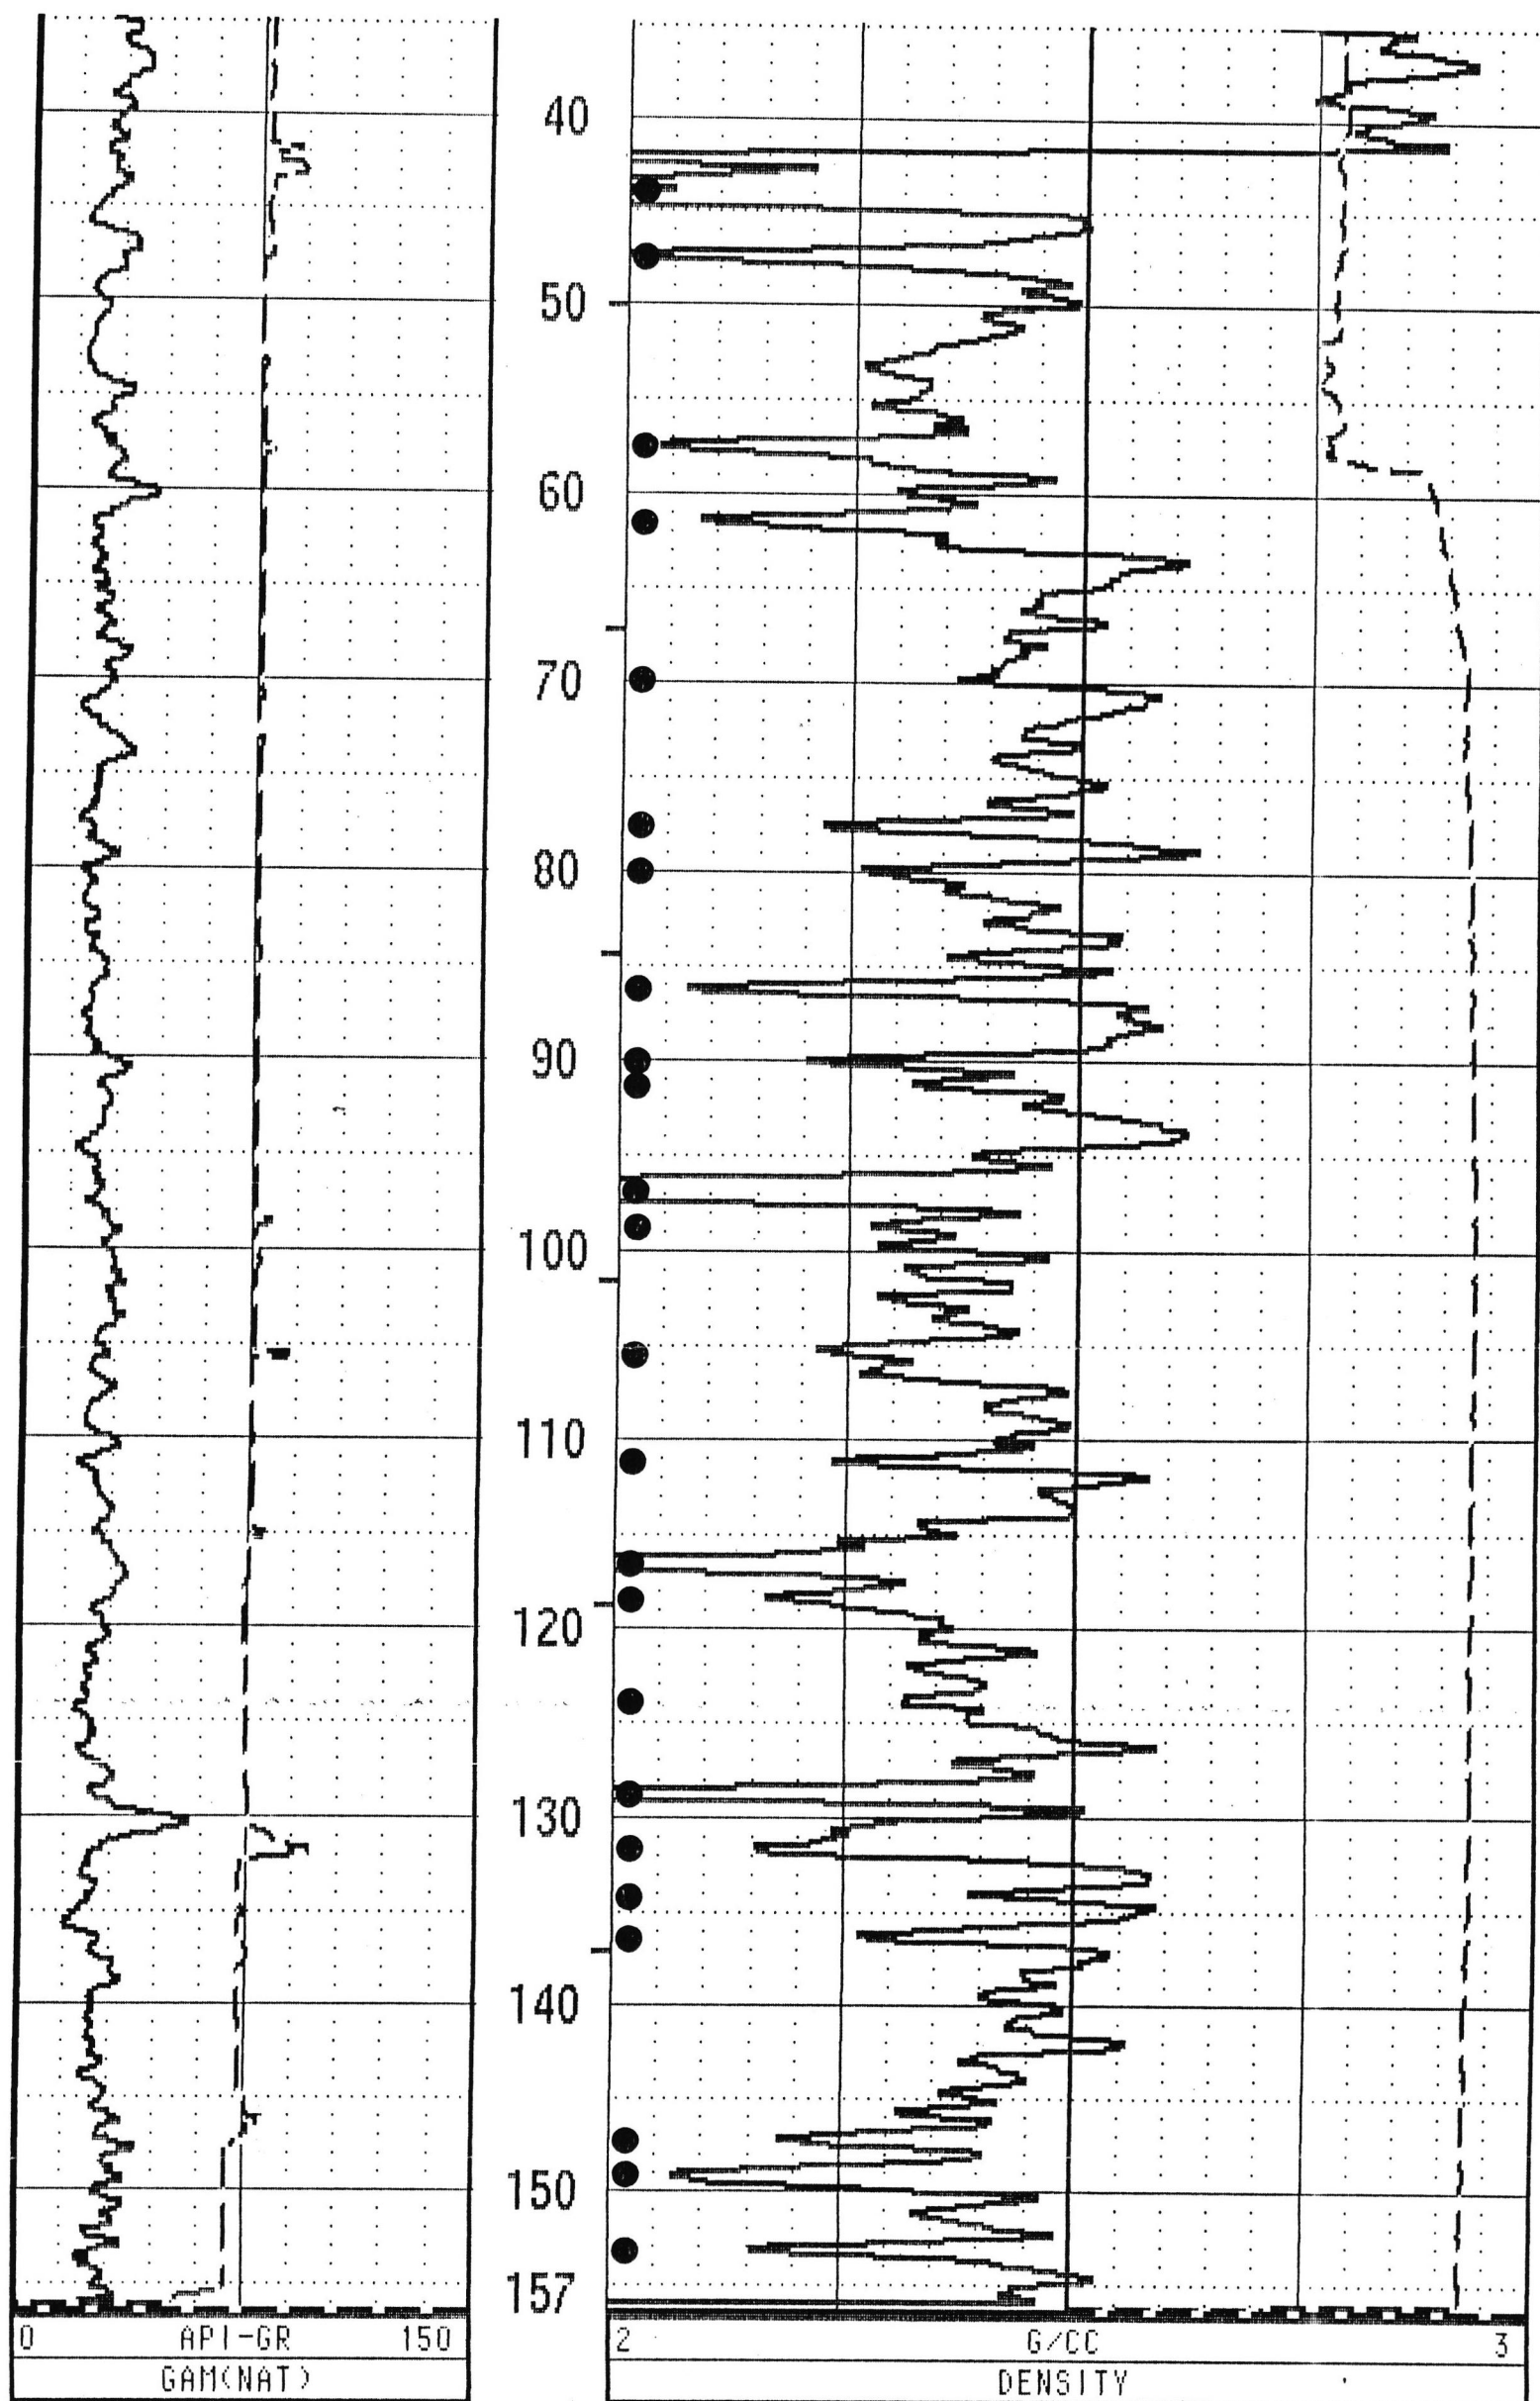
FIGURE 10
INTERPRETED FRACTURES
MW-4

The resistivity log for MW-4 confirms steel casing installed to a depth of 43 feet. Rock beneath this casing is shown to be fairly high in resistivity and is fairly uniform. This resistivity signature is similar to that in the other three wells and is consistent with carbonate rock. Major changes in the lithology are not indicated by the resistivity and the gamma ray curves. The presence of fractures and possibly minor lithology changes is suggested by the spiking in the resistivity signature.

The density log for MW-4 strongly resembles that for MW-3 and displays substantial spiking of low density events. In the apparent absence of rapid lithologic changes, these lower density spikes are interpreted as evidence of secondary porosity resulting from fractures. The gamma marker occurs at 130 feet on the log. The density log shows the marker to be thinner relative to the other logs, possibly about one foot thick. Its density signature indicates relatively high density, which is not supportive of porosity. The neutron log for MW-4 generally resembles the density log and generally supports the conclusions for that tool.
